# Littoral Zone Restoration Research Project 2007-2009

## Year 1 Report

Crooked, Chapman, Tippecanoe, and Wawasee Lakes  
Steuben and Kosciusko Counties, Indiana

December 19, 2007

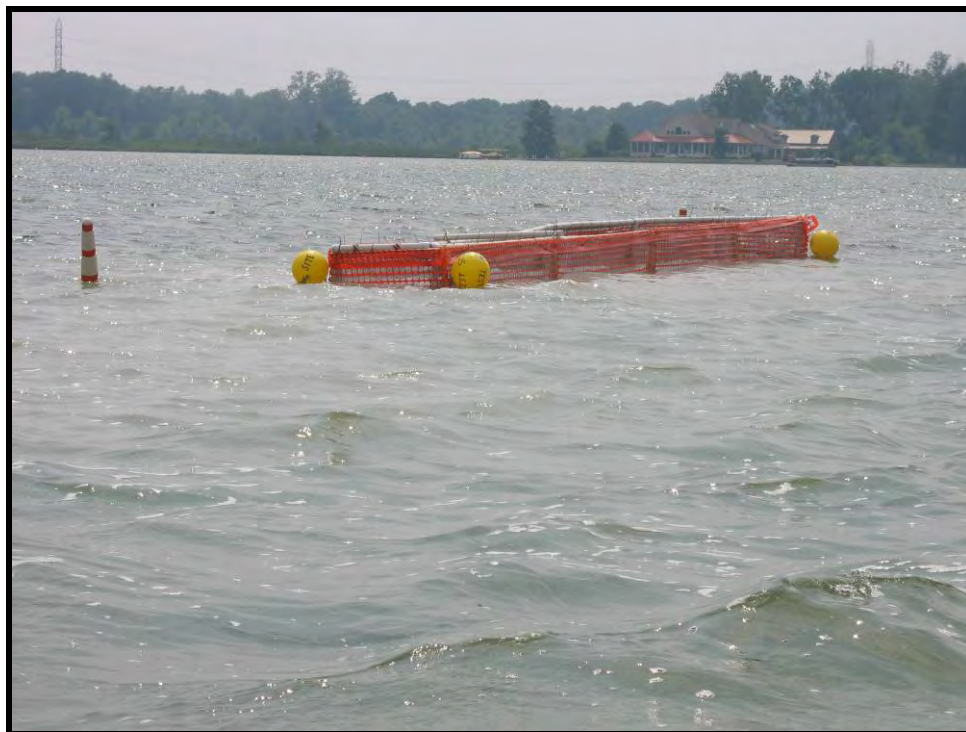
**Figure 6. Completed exclusion structure immediately following installation.**

and stapled to wooden slats (0.4 in thick by 1.2 in wide by 3.2 feet long or 1 cm thick by 3 cm wide by 1 meter long) placed along each edge. The wooden slats were then pre-drilled to receive cable ties on approximately 3.9-inch (10 cm) spacing. Each hardware cloth panel was then secured to the PVC frame horizontal and vertical posts and to the adjacent panel using a minimum of 16 plastic cable ties per panel. The structures extended 2 to 8 inches (5.1 cm to 20.3 cm) of clearance above the water level after installation. Figure 6 displays a typical structure installed during Year 1 of the project.

All four exclusion structures were marked to increase visibility in several ways. The entire PVC and hardware cloth frame was wrapped with high visibility orange snow fence which was then stapled to the wooden structure and cable tied to the PVC frame. A sign was posted on a PVC post adjacent to each structure briefly describing the project and provided a contact for additional information. Two navigational buoys were cabled to 12-inch (30.5 cm) wide concrete blocks and sunken into the substrate (one on either side of the structure). The navigational buoys were cylinder type buoys measuring approximately 2.5 feet (0.8 m) high and rode approximately 1.5 feet (0.5 m) above the water line. A minimum of four 6 to 8-inch (15.2 to 20.3 cm) inflated yellow ball-type buoys were tied or cabled to the structure itself. Additionally, reflective tape was applied to each end and at several places along each side of the PVC frame above the water line. Visibility was at least 165 feet (50 m) and some structures could be seen from across the lake without visual aids (a distance of several hundred feet).

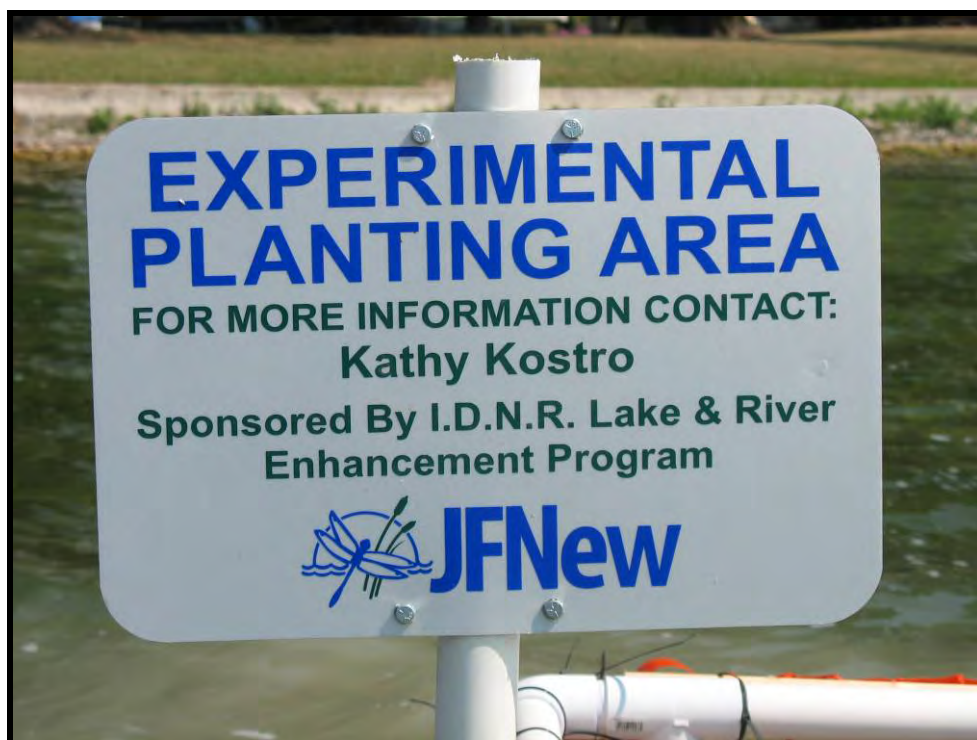
**Figure 7. Sign posted at each planting site.**

During the July 10 and 12 monthly monitoring visits, signs were posted outside the enclosure at each lake. Each sign identified the plot as part of an experimental planting project and provided a contact name and preferred contact information for each lake volunteer. Figure 7 shows for an example of the sign posted.

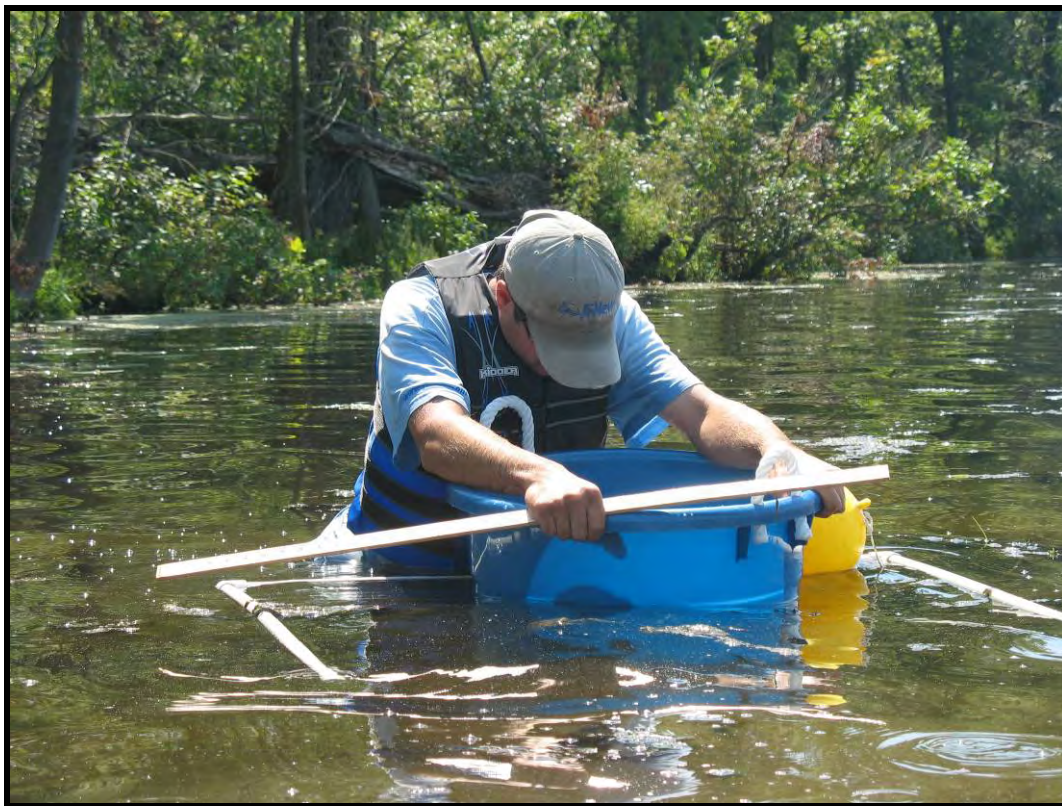
**Figure 8. Underwater plant viewer in use during monitoring of the treatment areas during 2007.**

JFNew monitored the survival and growth of the plants once during the growing season, on August 28, 2007 (Wawasee, Tippecanoe, and Chapman lakes) and August 29, 2007 (Crooked Lake). During this monitoring visit, a botanist and field technician visited the treatment areas within each lake. Monitoring was performed by using an underwater plant viewer, which was constructed from a plastic tub with clear Plexiglas installed on the bottom. The underwater plant viewer was nearly submerged in the water to provide the monitor a way to view submerged vegetation (Figure 8). For each treatment, expansion zone, and control plot within the treatment area, the number of observed live-rooted vascular plants was tallied by species and each individual plant length was measured using a meter stick. (A sample data sheet can be found in Appendix H.) Measurements were collected from the longest stem or branch on a plant, from the substrate surface to the stretched tip of the plant. Notes were also made regarding whether planted individuals were flowering, fruiting, or vegetative. Any vascular plant species not planted but rooted within the plots, expansion zones, and control were also identified, counted, and noted on the datasheet. Fragments of plants were observed floating (not attached to rooted material) in several plots. These species were noted, but not counted toward the total number of plants in a given plot. Note that algae (including *Chara* spp.) were not counted in this study. Due to growth pattern and difficulty with measurement of individual stems, percent coverage of *Chara* was estimated within each treatment or expansion zone. A control plot was established outside of the enclosure using a square meter grid. The control was permanently marked with a buoy, and the location was surveyed with a GPS unit. The control plot was monitored using the same protocol used within the enclosure. Water depth was noted at each sampled plot. Photographs were taken of treatment and control areas using an underwater camera.

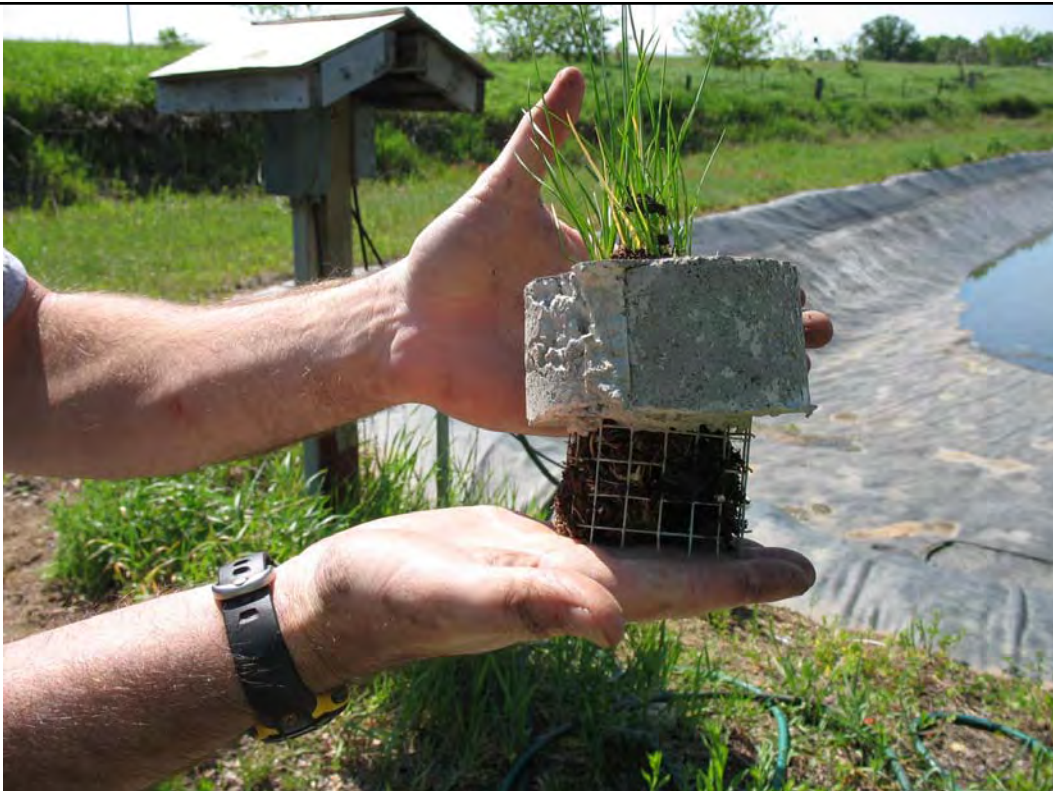
Planted concrete treatment (1 of 36 per treatment) prior to incubation period.

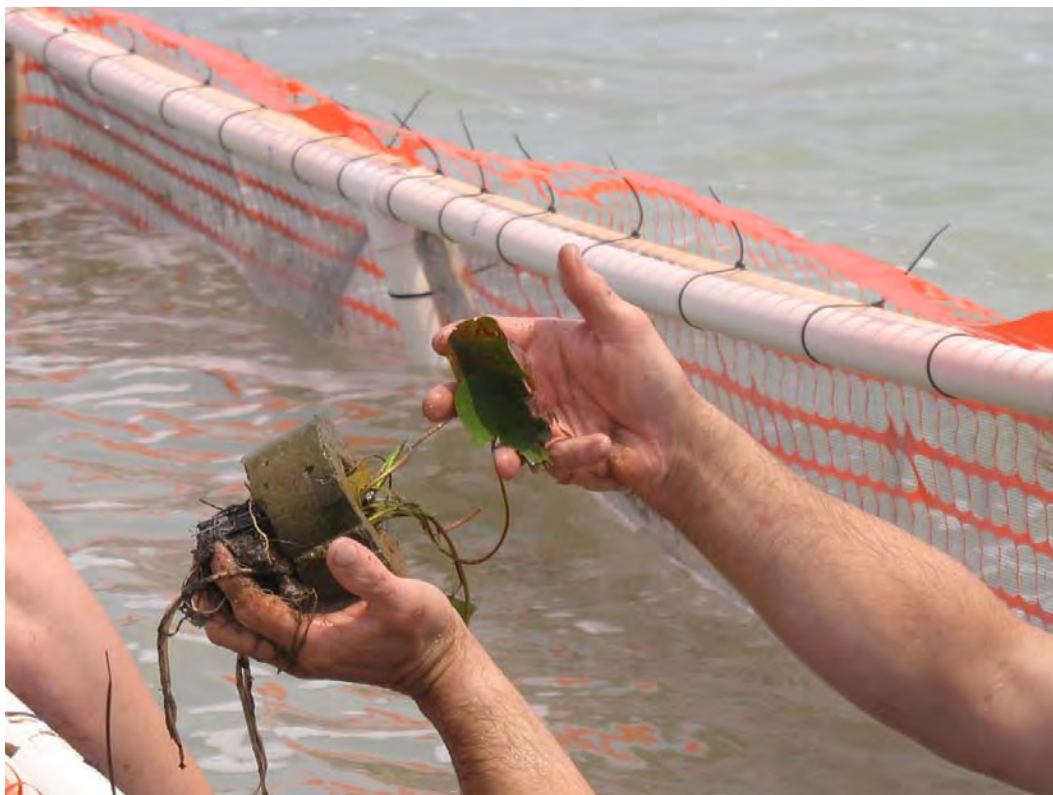
Planted concrete treatment prior to installation in the treatment at Chapman Lake.

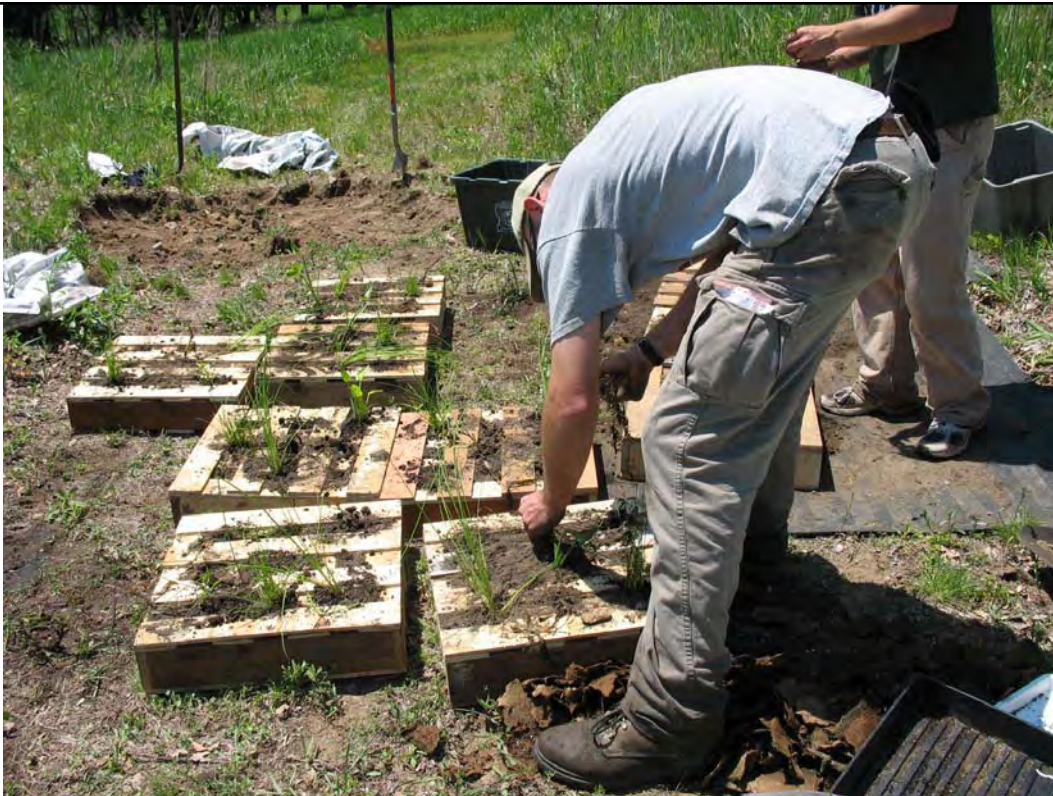
Wooden structure planting prior to incubation period. One set of four “crates” equals one treatment

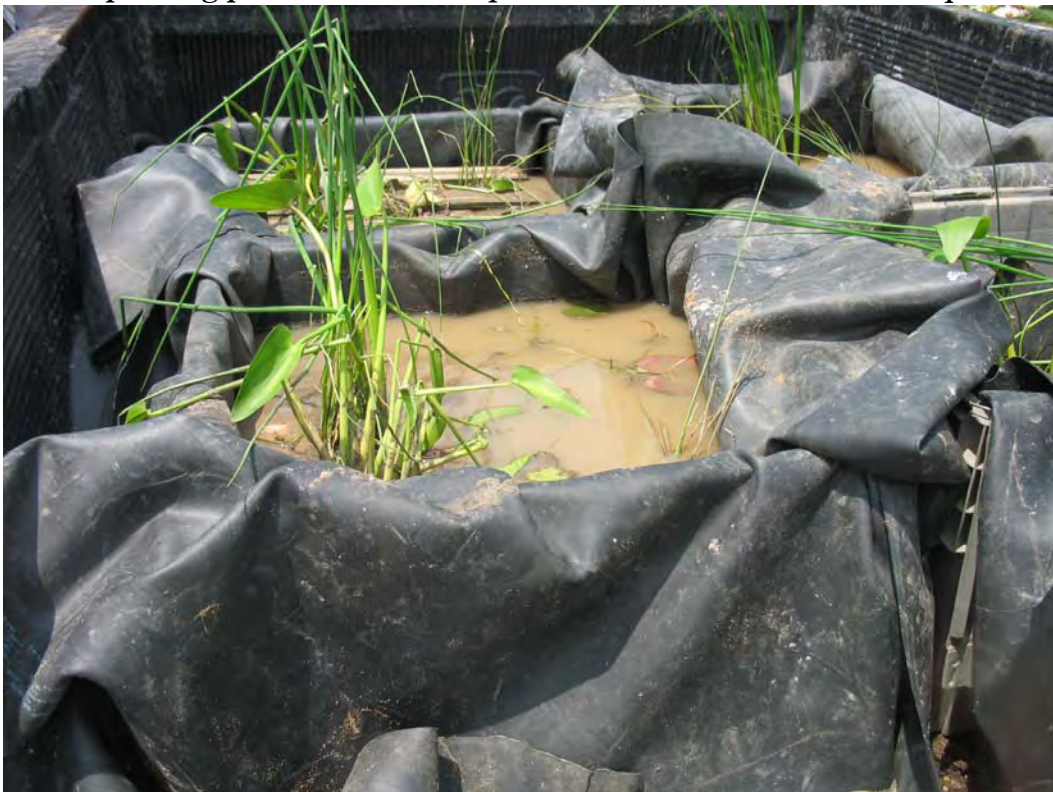
Planted wooden treatment prior to installation in the treatment at Lake Wawasee.

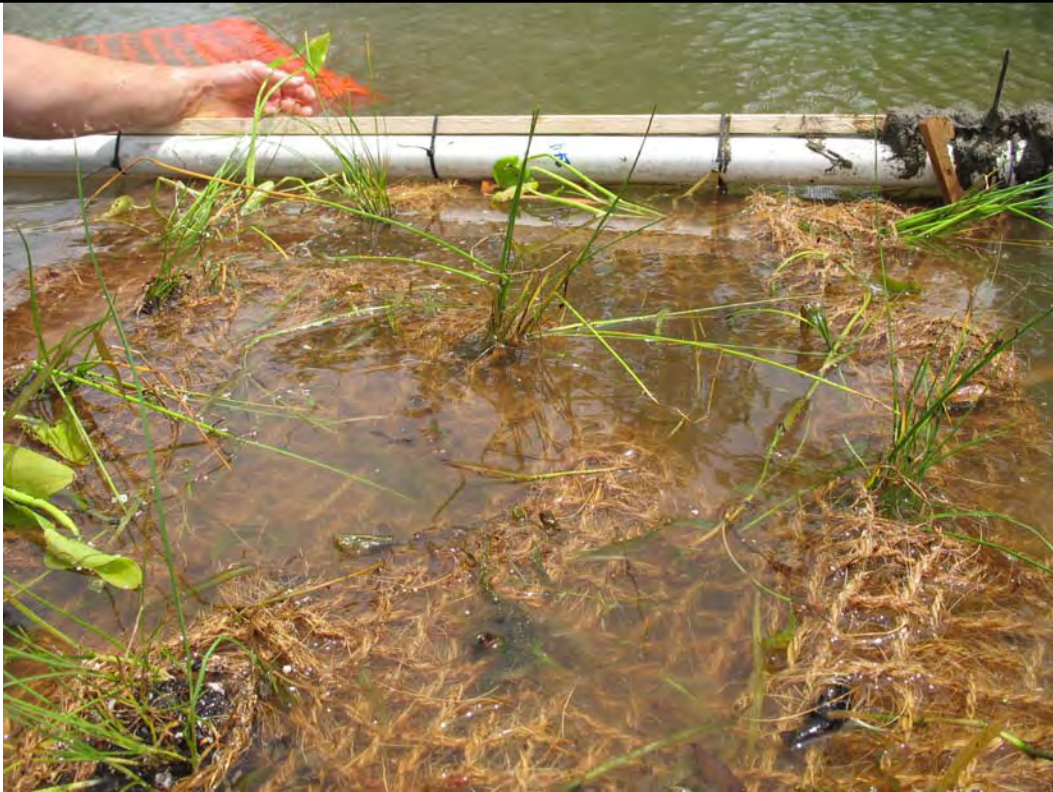
Coconut fabric planting prior to installation in Lake Tippecanoe.

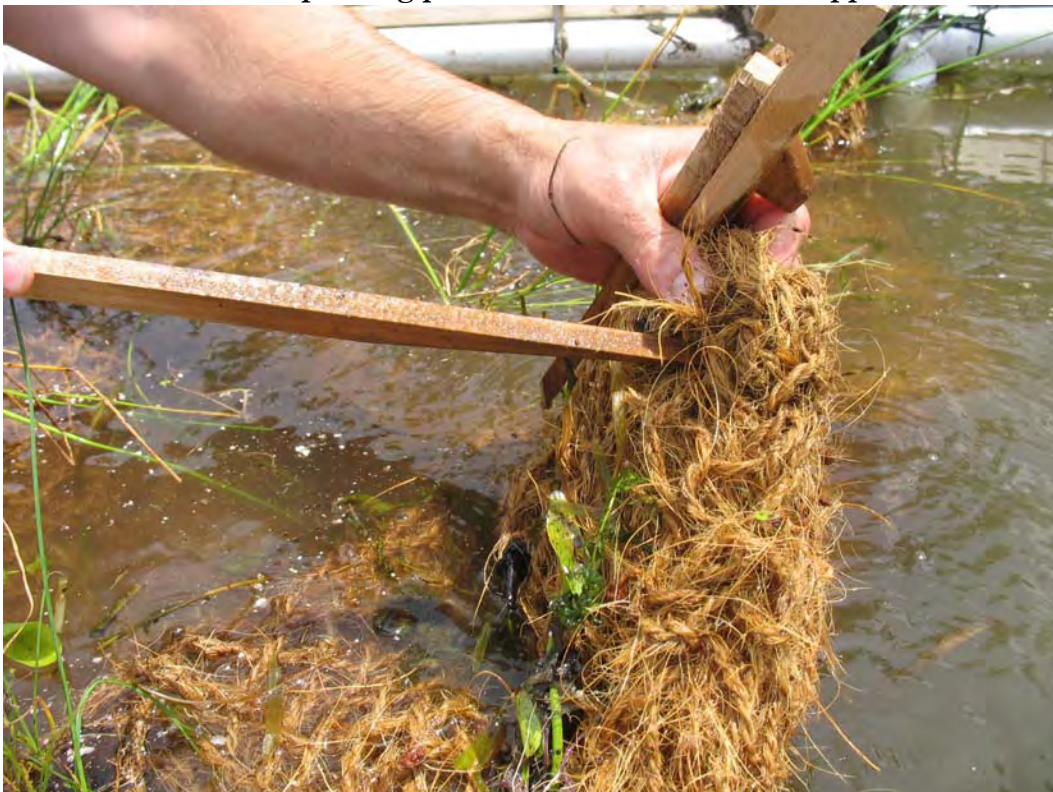
Coconut fabric staking during installation at Lake Tippecanoe.
